STRUCTURE NO. 1 - WILLIAMS CREEK

Structure Number 1 - Williams Creek Dam
(MO 10728), Missouri - Kansas City Basin,
Clay County, Missouri. Phase I Inspection
Report.

PREPARED BY: HOSKINS-WESTERN-SONDEREGGER, INC.

11 AUG 1978

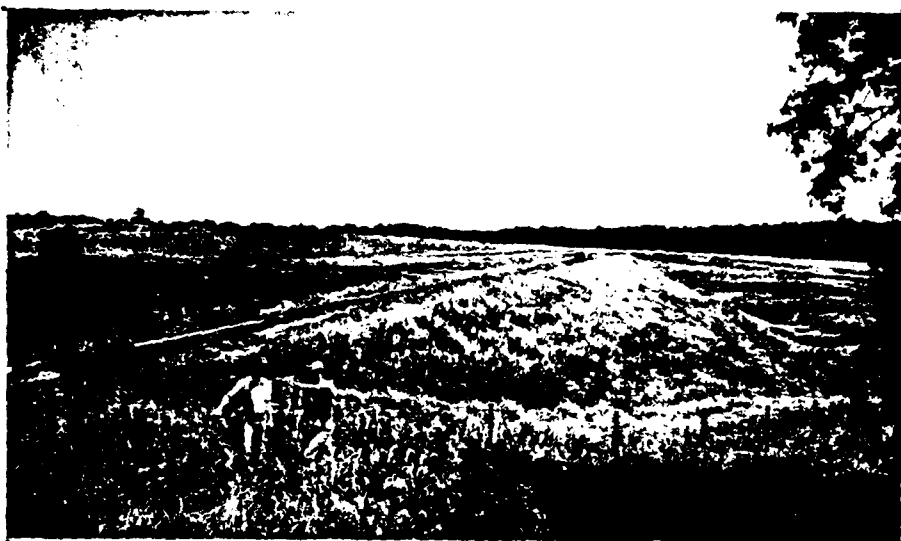
A small erosion gully, about 1 foot deep, was found along the upstream side of the berm on the downstream slope, along the right abutment.

PHOTO NO. 3
DOWNSTREAM SLOPE
FROM RIGHT
ABUTMENT

(3) Erosion damage should be repaired where the downstream toe ditch joins the berm in the right abutment. The installation of some type of ditch check or ditch lining is recommended.

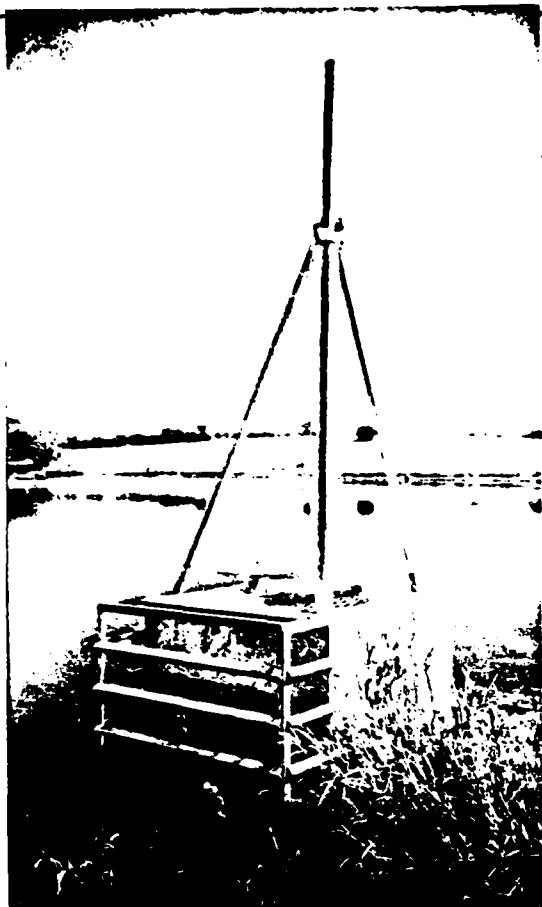
PHOTO NO. 5
PRINCIPAL SPILLWAY
INLET

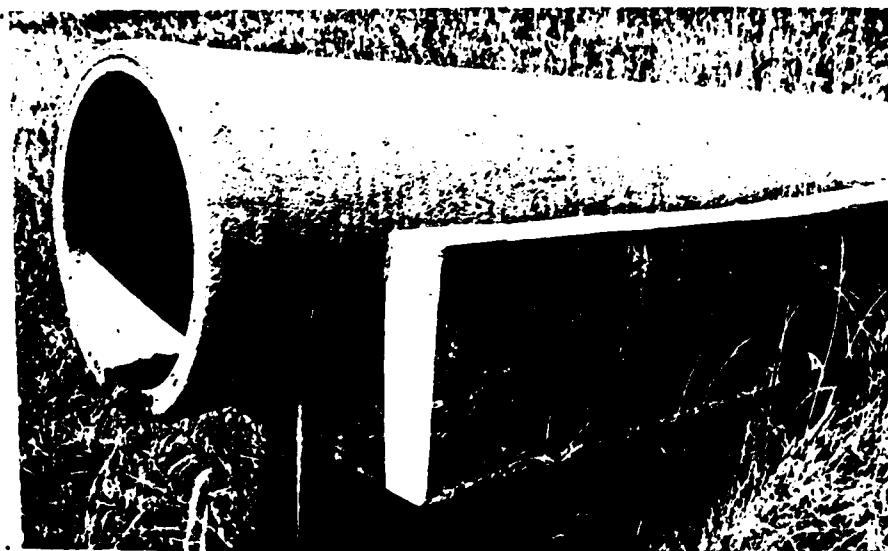
PHOTO NO. 7
PRINCIPAL SPILLWAY
OUTLET

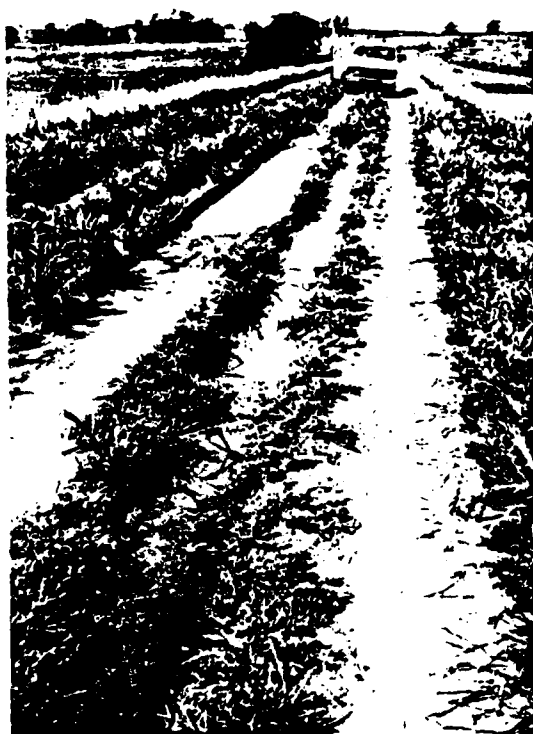
b. Dam. The upstream and downstream slopes are well-vegetated with grasses. Rough measurements along the crest of the dam indicate several places where the elevations are lower than the ends of the dam. Several of these low areas are ponding water for long periods of time. Tadpoles were noted in several of the ponds. Deep ruts have been formed by vehicles moving through these areas.

PHOTO NO. 9
CREST ABOUT STA. 5+50.
WATER IN LOW AREA
AND IN RUT

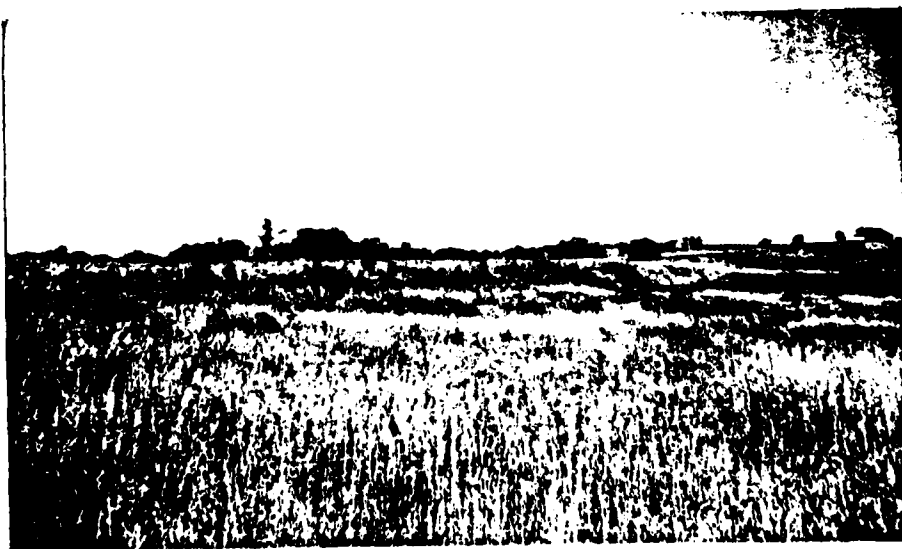
PHOTO NO. 10
UPSTREAM SLOPE
FROM LEFT
ABUTMENT

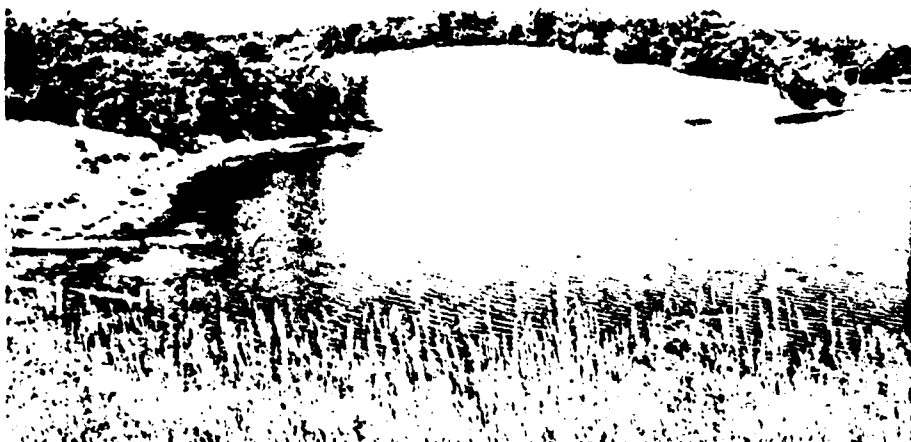
PHOTO NO. 11
RIGHT SHORE
OF RESERVOIR
FROM DAM
